Thomas C. Kelly
Administration Building

CPI DAYLIGHTING *solutions*

A Governing Eye

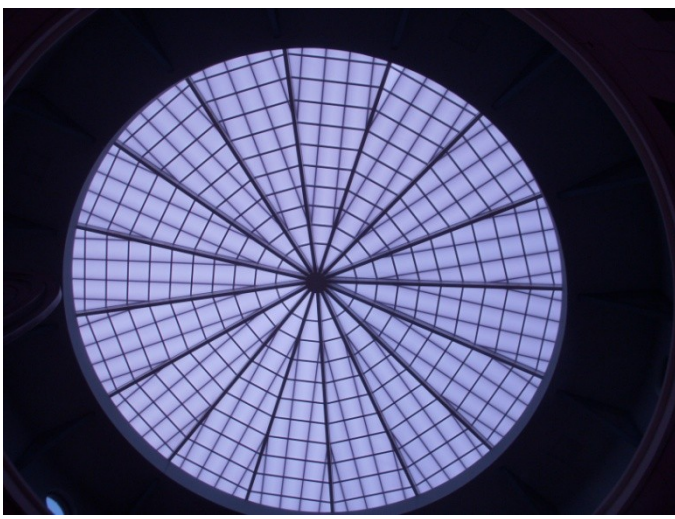
Over the years the rotunda's fiberglass sandwich panels darkened and fell prey to significant leaks, accumulating algae and residue, leaving the dirty appearance of mold in many areas. After years of unsuccessful attempts at refinishing and resealing the panels with their original manufacturer, the iconic dome spent the last six months of its life covered with blue tarps to minimize seepage.

"The fiberglass sandwich panels were starting to deteriorate because what was leaking inside wasn't just water, but more of a fiberglass resin that was sticky and had an odor," said Pete Musslewhite, facilities engineer for the County of Volusia. "It was staining the precast concrete staircase on the way up to the county council chambers. We finally decided we needed to replace it.

"CPI came out and decided they could use the original framework, beef it up a little and then put their polycarbonate panels on top," Musslewhite continued. "It came in at less money than at what the competitors wanted to replace their panels."

The County of Volusia specified CPI Daylighting's 4-in. Quadwall advanced scalable daylighting system in Ice White matte, anti-glare finish, for the interior and Ice White exterior glazing, complete with stainless sill flashings and welded segments, all custom engineered by CPI to fit the rotunda's existing 16-sided polygon of aluminum rafters. The Quadwall system requires no maintenance and provided a much-needed double-paneled building envelope that can stand up to both Florida's high wind uplift requirements of 120 mph and its typical yearly rainfall.

Deteriorated panels were replaced with custom engineered translucent panels to fit the existing aluminum rafters.

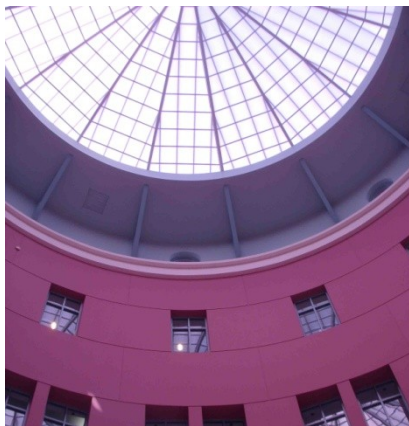
Newly refurbished rotunda with CPI Quadwall advanced scalable daylighting system provides three and half times the daylighting.

Working nights and weekends, installation crews avoided disrupting daily building operations and completed the project in just six weeks time. With three and half times the daylight and without the risk of mold, bad odors or depressing light levels it had previously, Ripley said the newly refurbished rotunda has a diffused light that is "much brighter and more pleasant, without the glare of a clear skylight system."
