# Renovation & Retrofit Solutions

Skylights + Walls + Canopies

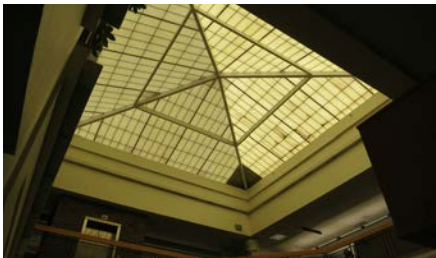
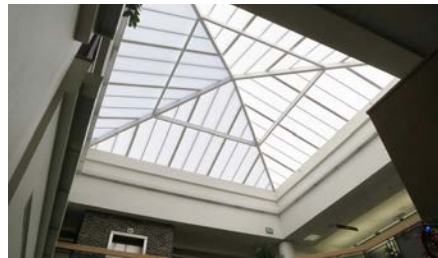
### Fiberglass

Fiberglass systems that have severely discolored or are experiencing structural degradation can be easily replaced. Our systems are designed with added color stability and UV protection to enhance longevity.

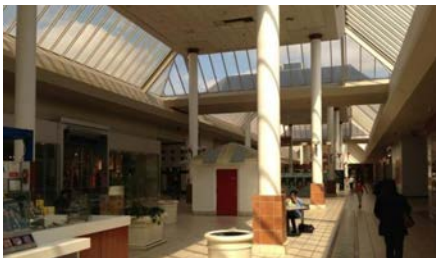
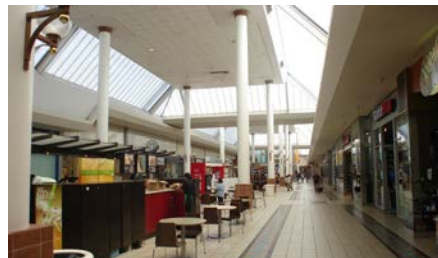
### Acrylic

Acrylic can become brittle, crack and leak, or may discolor over time. Our systems are often used to replace these underperforming acrylic units, many of which no longer meet strict fire codes. We offer Class A, B and C fire-rated systems depending on your building needs.

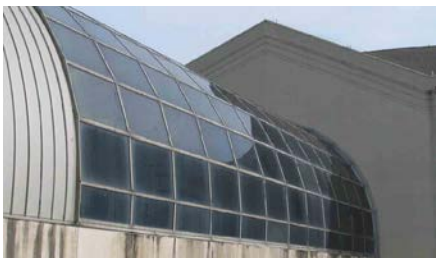
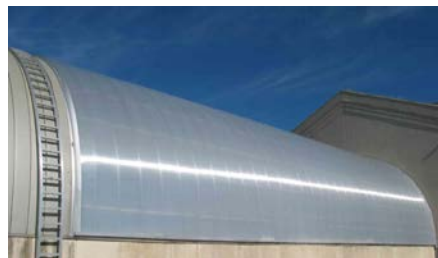
### Glass

We can reglaze, overglaze and replace glass systems that are leaking, or are otherwise compromised. Our systems offer glare-free diffused light which significantly reduces solar heat gain - a problem often associated with glass units.

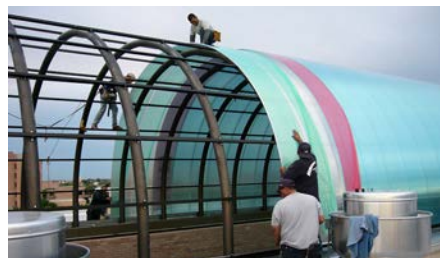
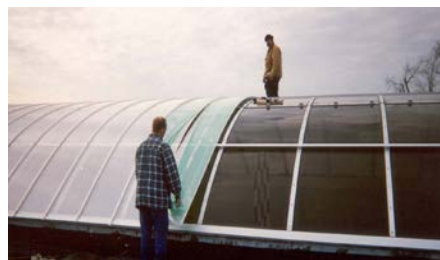
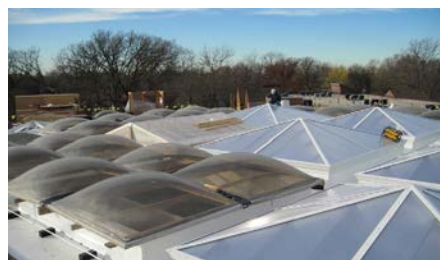
## Reglaze

The glazing system will be replaced and the existing structure will be evaluated and reused when possible.

## Overglaze

Pentaglas® systems can be designed to envelop leaking systems if their performance is otherwise uncompromised. This option is typical for systems that provide enough light, but may be deteriorating, leaking or need additional insulation performance.

## Replace

The entire existing system is disassembled and removed and a new system will be installed in its place.

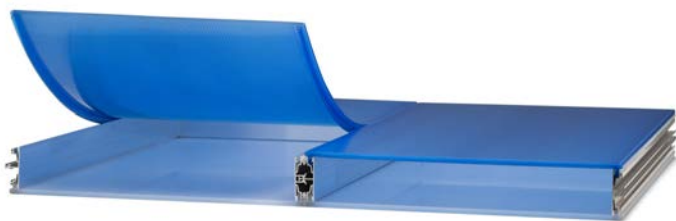
### Removable Skin Technology (RST)

The system is designed so that the interior and exterior glazing panels are independent of one another. Once installed, the interior panels remain intact, and each of the exterior panels can be disengaged and removed without compromising the integrity of the building envelope.

Removable skin technology ensures that if there is a future need for updating the exterior, those panels can be changed without interrupting ongoing building operations. The flexibility to replace individual panels, rather than the entire system, adds another level of dimensionality to a system that is already extremely versatile.

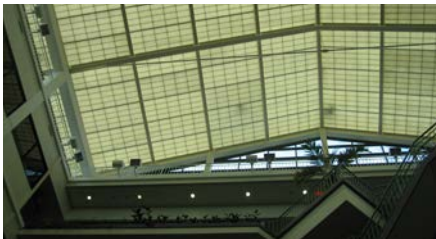
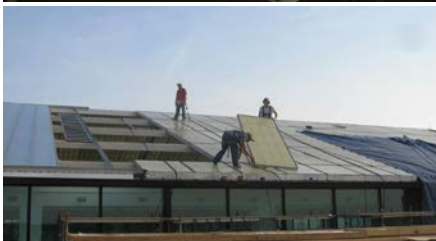
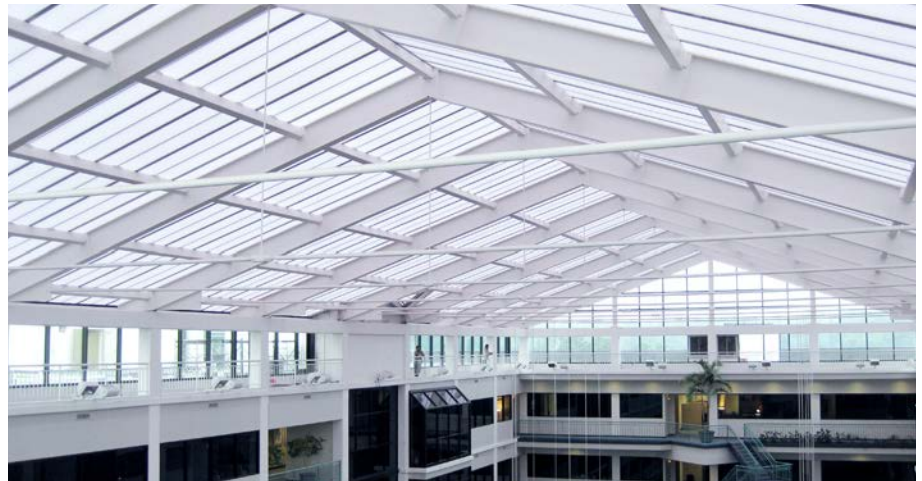
## SAS Institute | Cary, NC id 21392

**Problem:** The 19,000 sq. ft. ridge skylight over the main atrium was severely discolored and deteriorating, resulting in a dark and dingy workspace.

**Solution:** The system was replaced by CPI's Quadwall® skylight system, resulting in a dramatically improved work environment. The translucent glazing, with its matte finish, provides occupants with all of the benefits of natural light without glare and excessive heat gain.

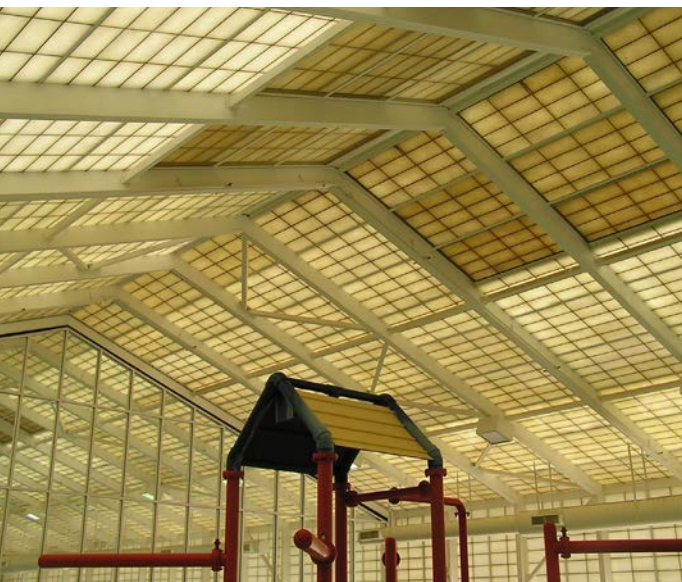
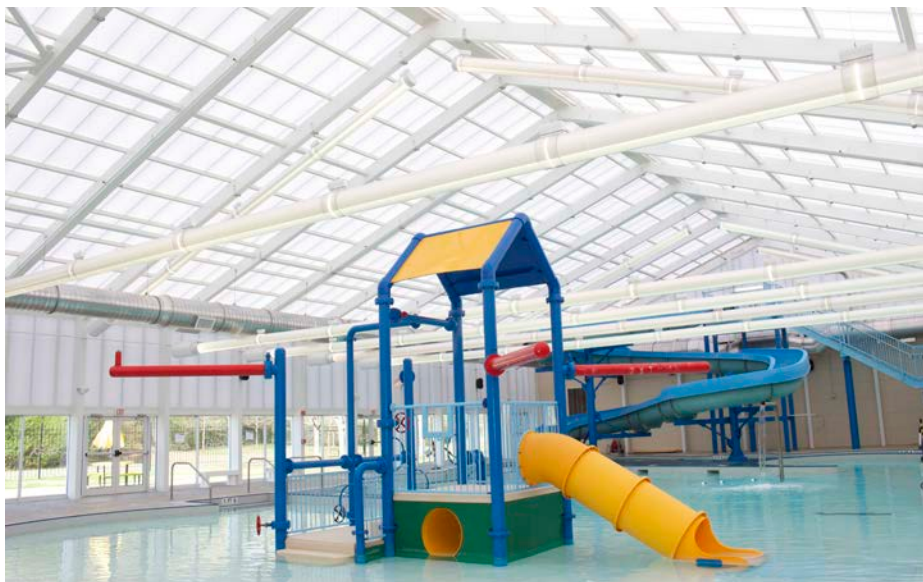
## Bogan Park Aquatic Center | Buford, GA id 33261

**Problem:** After only 15 years, the skylight had completely degraded and discolored, resulting in a dark and grungy environment for pool patrons.

**Solution:** CPI successfully replaced 17,390 sq. ft. of translucent fiberglass roof covering and 2,490 sq. ft. of vertical walls. The existing support beams remained intact and were reused along with some additional structure. Meticulous and concise coordination resulted in a 40% reduction in install time.

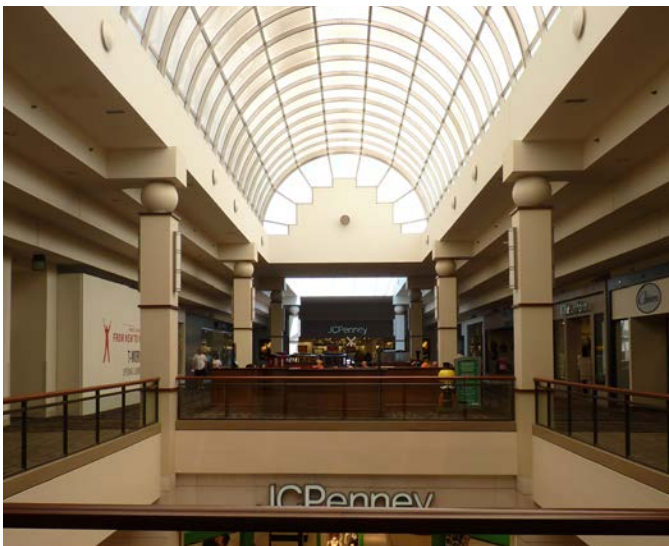
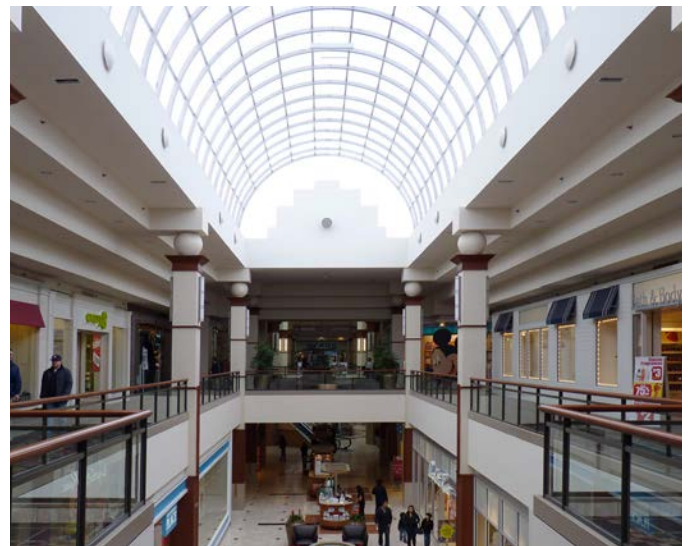
## Town Center at Cobb

**Problem:** The existing 26-ft. x 120-ft. acrylic barrel vault skylight had failed and was beginning to leak, which created a life safety liability for shoppers. The intense glare and poor light diffusion also created an unpleasant visual environment for mall-goers and tenants alike.

**Solution:** Fortunately, much of the existing structure remained, which helped curb the cost of the replacement. The skylight was then replaced with CPI's Quadwall® system, which provided an even distribution of natural light that gave new life to the mall. The superior thermal and solar performance of the new skylight system also helped to better optimize building efficiency and substantially reduced utility costs.

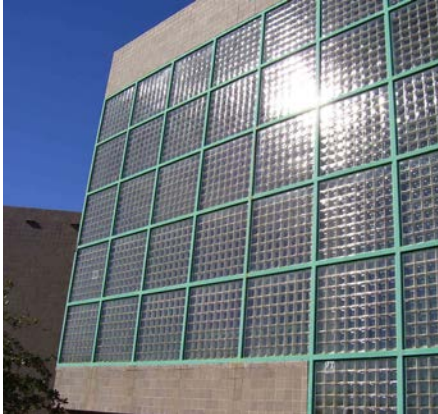
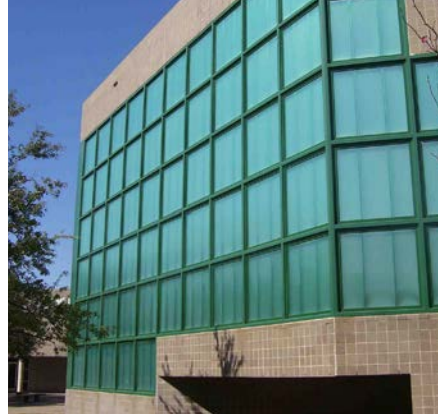
## Mayde Creek High School

**Problem:** The School's main glass-block stairwell saw significant structural decline as a result of vandalism and maintenance challenges.

**Solution:** Approximately 7,500 sq. ft. of CPI Daylighting's Quadwall® 2 3/4 in. thick translucent two panel system was used to replace the existing facade. The new translucent system significantly reduced the heat gain in the stairwell and provided an impact-resistant façade.

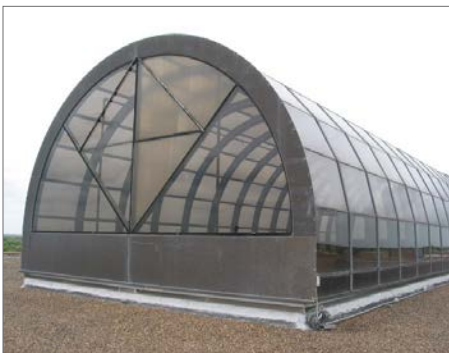
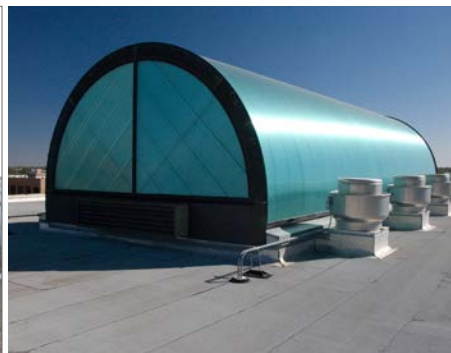
## University of Texas-Pan American

**Problem:** Existing glass skylight had deteriorated and was plagued by water leaks at the horizontal joints.

**Solution:** The skylight glass was removed and the existing structure was reglazed with CPI's two panel Quadwall® translucent skylight system. The individual panel lengths span continuously, eliminating entry points for leaks.

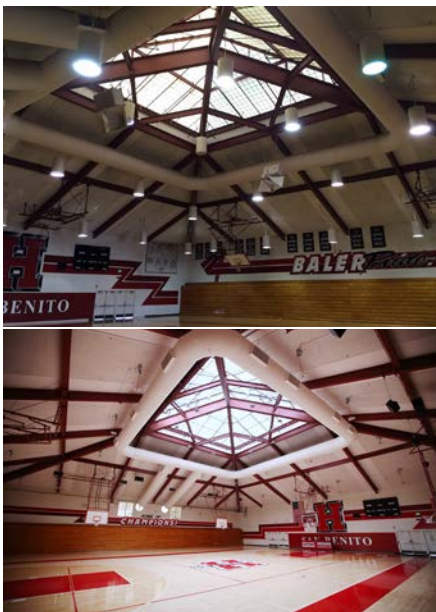
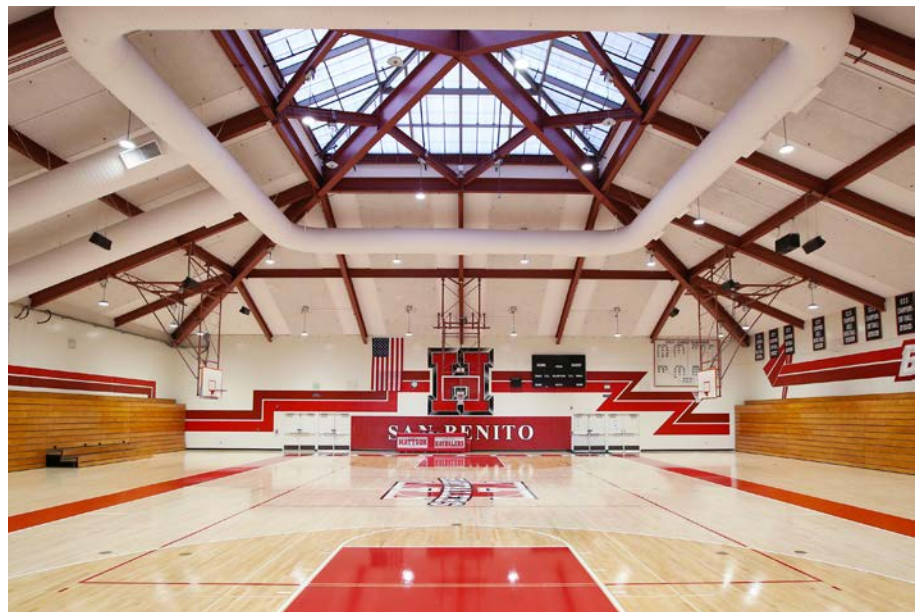
### San Benito High School

**Problem:** The existing 40-ft. x 40-ft. skylight had discolored and was in need of replacement. Because the gym is used as a multipurpose space for a variety of different function, the new system needed to be able to control the amount of light allowed to enter the space.

**Solution:** The old skylight was replaced by CPI Daylighting's IntelaSun® controlled daylighting system, which features a series of internal blades that rotate to control the amount of light within the space below.
